TECHNICAL REPORT REMR-CO-3

**CASE HISTORIES OF CORPS BREAKWATER
AND JETTY STRUCTURES**

Report 3

NORTH CENTRAL DIVISION

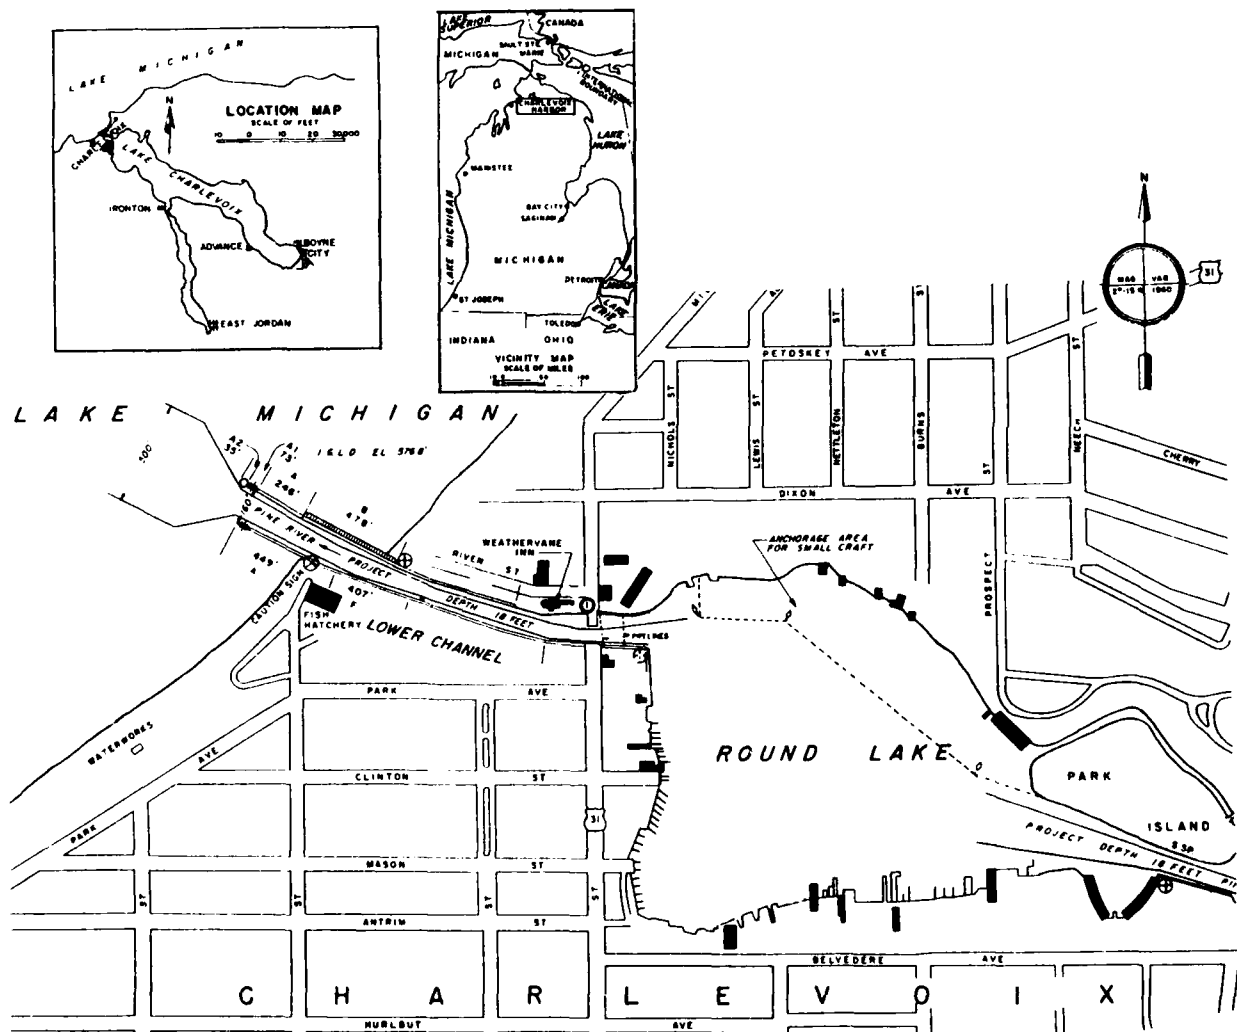
Figure 163. Charlevoix Harbor, Michigan

Date(s)	Construction and Rehabilitation History
1872	Construction of a north pier (Figure 163, Section B) was completed. The structure was a 20-ft-wide stone-filled timber crib.
1879- 1880	Construction of the lakeward portions of the north and south piers (Figure 163, Sections A and A-1) was completed. The piers consisted of stone-filled timber crib structures (Figure 164, Sections A and A-1) that were 20 ft in width.
1882	Construction of a shoreward portion of the south pier (Figure 163, Section F) was completed. The pier consisted of woodpilings driven approximately 20 ft apart (Figure 164, Section F) and filled with stone.
1897	Rubble was placed along the lakeside and over the shoreward portion of the north pier (Figure 163, Section B). The crest width of the rubble structure (Figure 164, Section B) was 10 ft, and it had an el of +8.1 ft lwd. Side slopes were 1V:2H, and the cover stone used was 1,000 lb (min).

1930	The shoreward portion of the south pier (Figure 163, Section F) was repaired and capped with a concrete and stone superstructure (Figure 164, Section F). The crest el of the pier was +7.1 ft lwd.
1942	The lakeward portions of the north and south piers (Figure 163, Sections A and A-1) were capped with concrete and stone superstructures (Figure 164, Sections A and A-1) with crest els of +7.0 ft lwd.
1966	The lakeward portion of the existing north pier (Figure 163, Section A-1) was repaired by encasing it between steel sheetpiling spaced 33 ft apart (Figure 164, Section A-1). The voids between the steel sheetpiling and the existing timber crib were filled with stone and capped with concrete to an el of +6.75 ft lwd. A 35-ft-diameter steel sheet-pile cell was constructed at the head of the north pier (Figures 163 and 164, Section A-2). The pier head was filled with stone and capped with concrete at an el of +7 ft lwd. Steel sheet-piles were also installed on each side of the shoreward portion of the south pier (Figures 163 and 164, Section F). On the channel side the void was filled with stone, and the crest was grouted at an el of +6.5 ft lwd.

1971	Replenishment of fill stone was performed on the lakeward portion of the south pier (Figure 163, Section A).
1981	Portions of the north (Figure 163, Sections A and B) and south (Figure 163, Section A) piers were rehabilitated. The existing timber

Date(s)	Construction and Rehabilitation History
	cribs were encased in steel sheetpiling (Figure 164, Section A). The voids between the steel sheetpiling and the cribs were filled with stone and capped with concrete at an el of +6.75 ft lwd. The rubble portion of the north pier (Figure 164, Section B) was repaired, and a concrete cap was included which had an el of +8.5 ft lwd.
1985	An inspection of the piers revealed them to be in fair condition. Settlement and loss of fill stone are evidenced in the piers, and some of the structures are cracked and tilting. Replenishment of fill with larger stone, and placement of riprap along the piers have been recommended. An aerial view of the Charlevoix Harbor piers is shown in Figure 165.

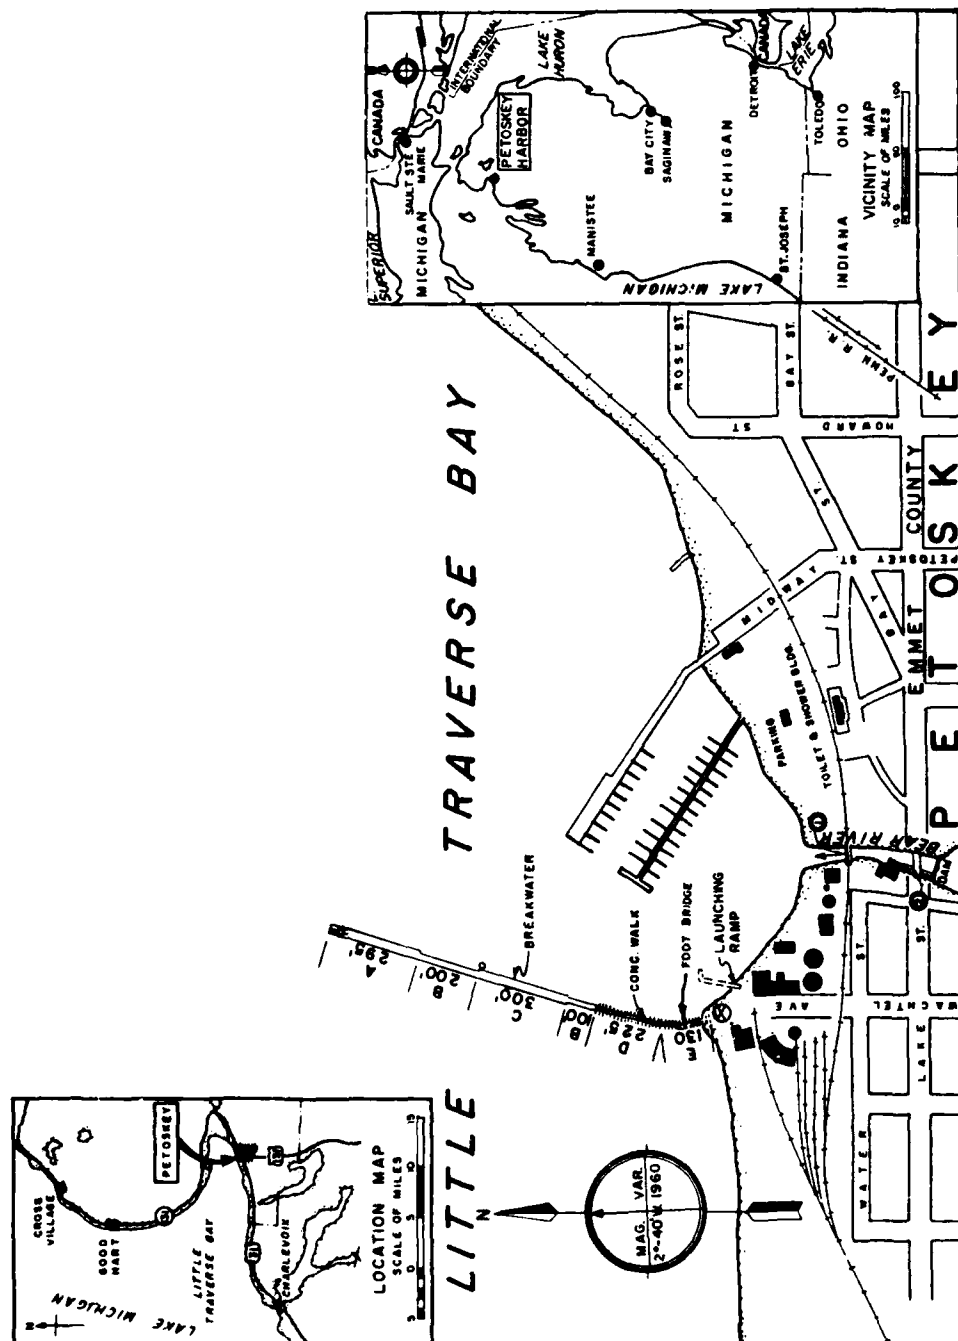
Figure 166. Petoskey Harbor, Michigan

Date(s)	Construction and Rehabilitation History
1895- 1896	Construction of a 600-ft-long portion of the breakwater (Figure 166, Sections B and C) was completed. This breakwater consisted of stone-filled timber cribs built on a stone base (Figure 167, Sections B and C). Part of the breakwater was 26 ft wide (Section B), and the remaining portion (Section C) was 28 ft wide.
1897	Construction of the 355-ft-long shoreward portion of the breakwater (Figure 166, Sections D and E) was completed. This portion of the breakwater was rubble mound with a 10-ft crest width and a +7.0 ft lwd crest el (Figure 167, Sections D and E). A concrete walkway was also installed on its crest.
1905- 1907	Construction of the lakeward end of the breakwater (Figure 166, Section A) was completed. This portion of the breakwater was a 30-ft-wide stone-filled timber crib built on a stone base (Figure 167, Section A).
1930	The lakeward 895 ft of the breakwater (Figure 166, Sections A, B, and C) was capped with a stone and concrete superstructure. The crest el of the breakwater was +7.0 ft lwd (Figure 167, Sections A, B, and C).

1949	The rubble-mound portions of the breakwater (Figure 166, Sections D and E) were rehabilitated.
1970	The rubble-mound sections of the breakwater (Figure 166, Sections D and E) were rebuilt (including the concrete walkway).
1973	Riprap stone (1 to 6 tons) was placed along both sides of the rubble-mound portion of the breakwater (Figure 166, Sections D and E).
1977	Riprap stone was placed in areas along both sides of the timber crib breakwater (Figure 166, Sections A, B, and C).
1978	Replenishment of fill stone was performed in the timber cribs (Sections A, B, and C), and additional riprap was placed along areas of the timber crib breakwater where stone was not placed in 1977. Riprap was also placed along the rubble-mound breakwater (Sections D and E) where washouts and voids existed.
1985	A site inspection of the breakwater indicated superstructure tilt, settlement, cracking, and loss of fill stone along the timber-crib portion of the structure (Sections A, B, and C) which suggests substructure deterioration. The rubble-mound portion of the breakwater

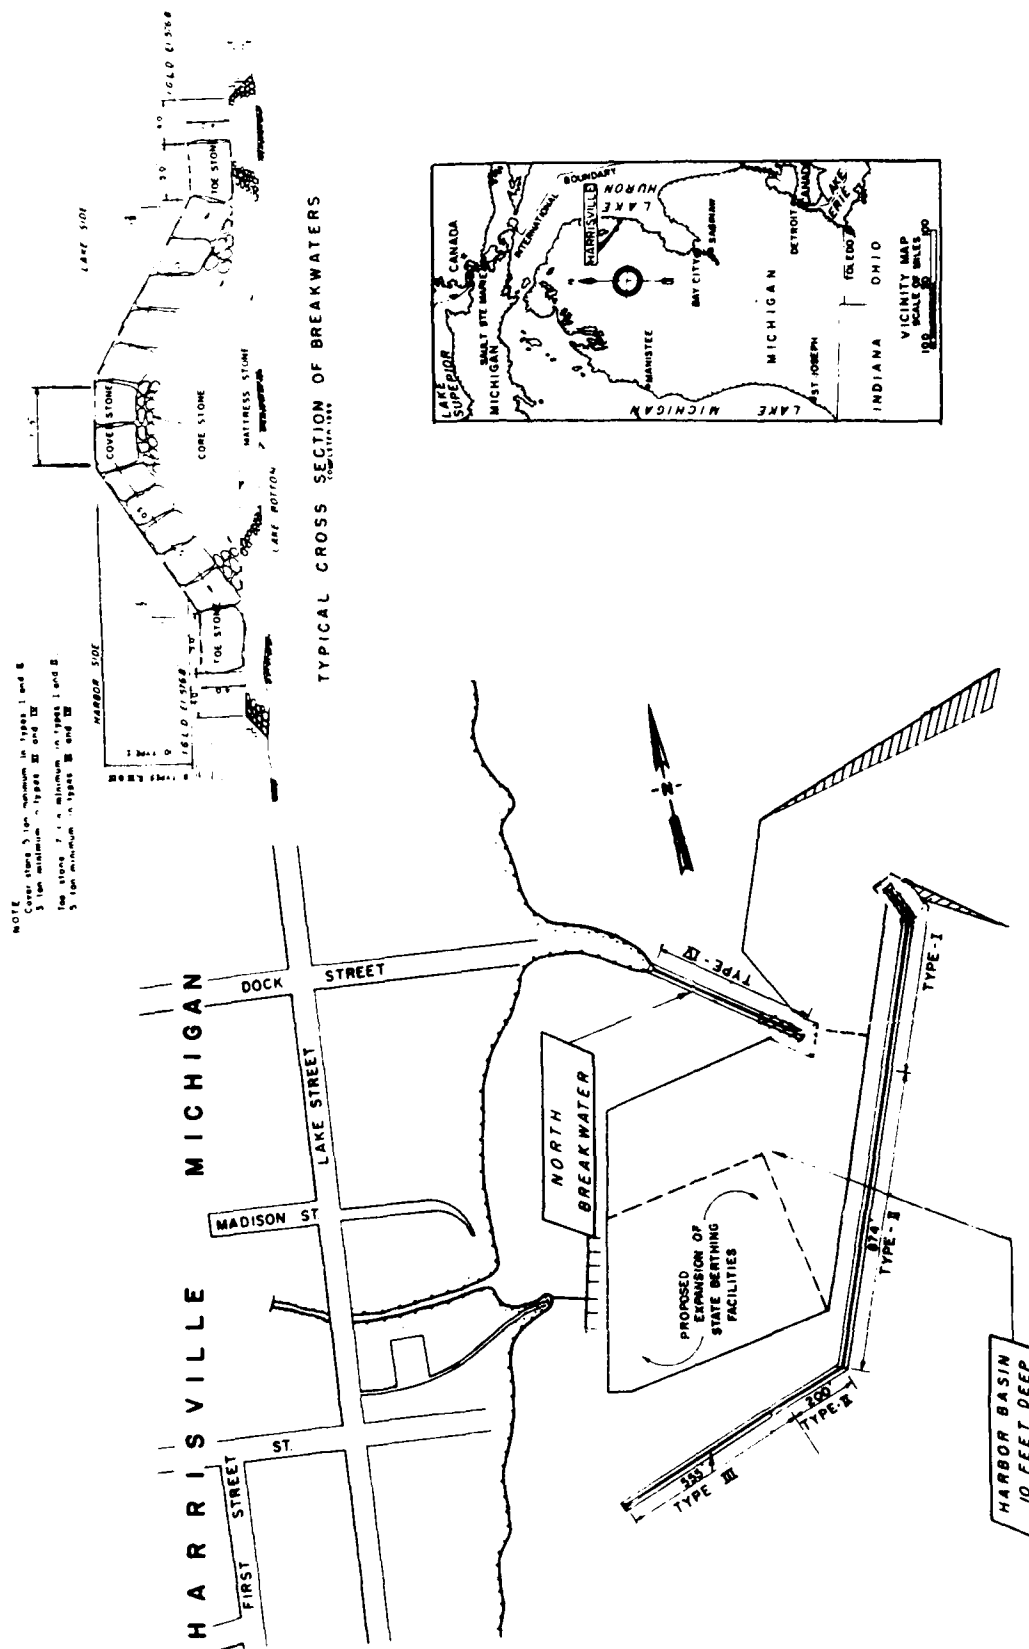
Figure 179. Harrisville Harbor, Michigan

Date(s)	Construction and Rehabilitation History
1959	Construction of a 360-ft-long north breakwater and a 2,170-ft-long south breakwater was completed (Figure 179). The breakwater was constructed of rubble-mound materials with cover stones ranging to 3 (min) and 5 tons (min) for Types III and IV and Types I and II structures, respectively (Figure 179). The lakeward end of the south breakwater (Type I) had a crest el of +10 ft lwd, and the remaining portions of the structure (Types II, III, and IV) had a crest el of +8.0 ft lwd. The crest width was about 7.5 ft; and side slopes on the lakeside of the breakwaters were 1V:1.75H, while side slopes on the harbor side were 1V:1.5H. Toe stone ranged from 5 tons (min) in Types III and IV to 7 tons (min) in Types I and II.
1971	Replenishment of cover stone on the breakwaters was accomplished.
1984	An inspection of the breakwaters revealed some winter storm damage since several cover stones were missing. An estimated 80 tons of stone would be required to repair the breakwaters.

1985	Extensions of the north and south breakwaters of approximately 140 and 110 ft, respectively, were completed (Figure 179, hatched ends) for a cost of over \$433,000. Cover stones up to 9.5 tons were used.
1986	The breakwaters, presently, are considered in fair condition. An aerial photo of the Harrisville Harbor breakwaters (prior to breakwater extensions) is shown in Figure 180.

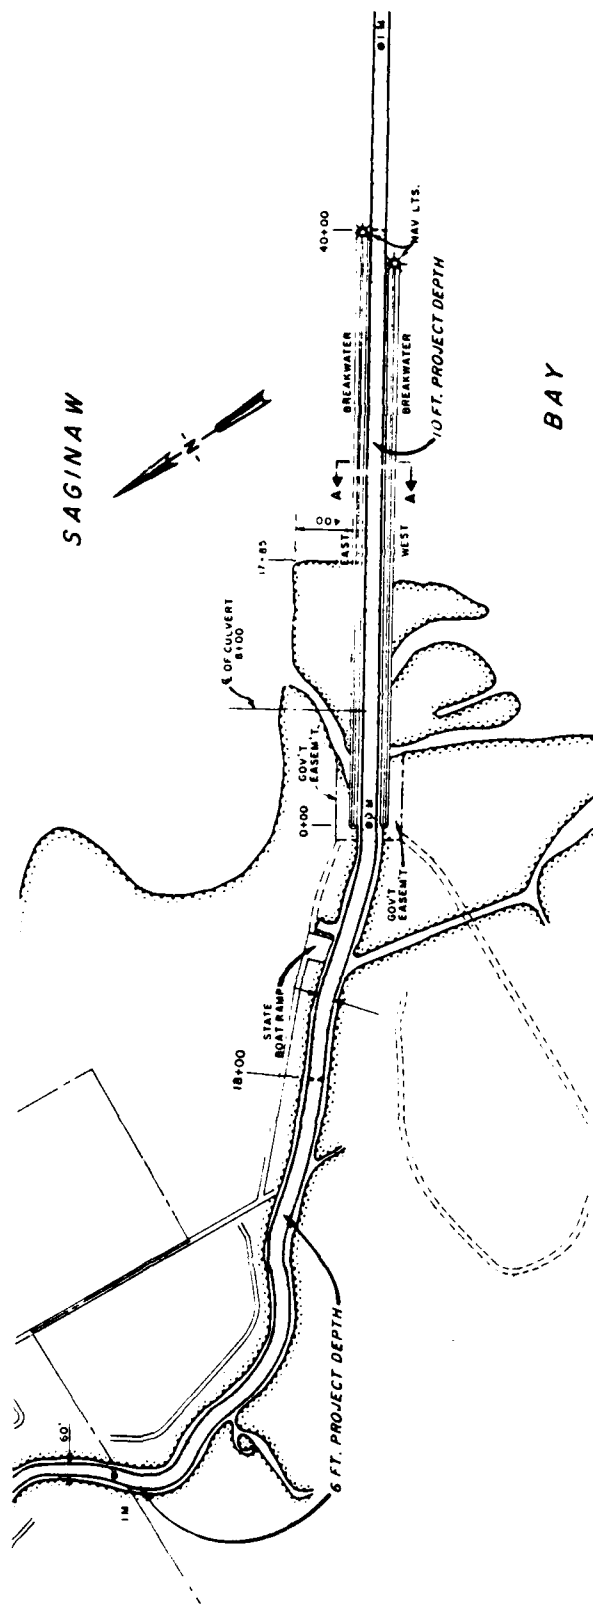
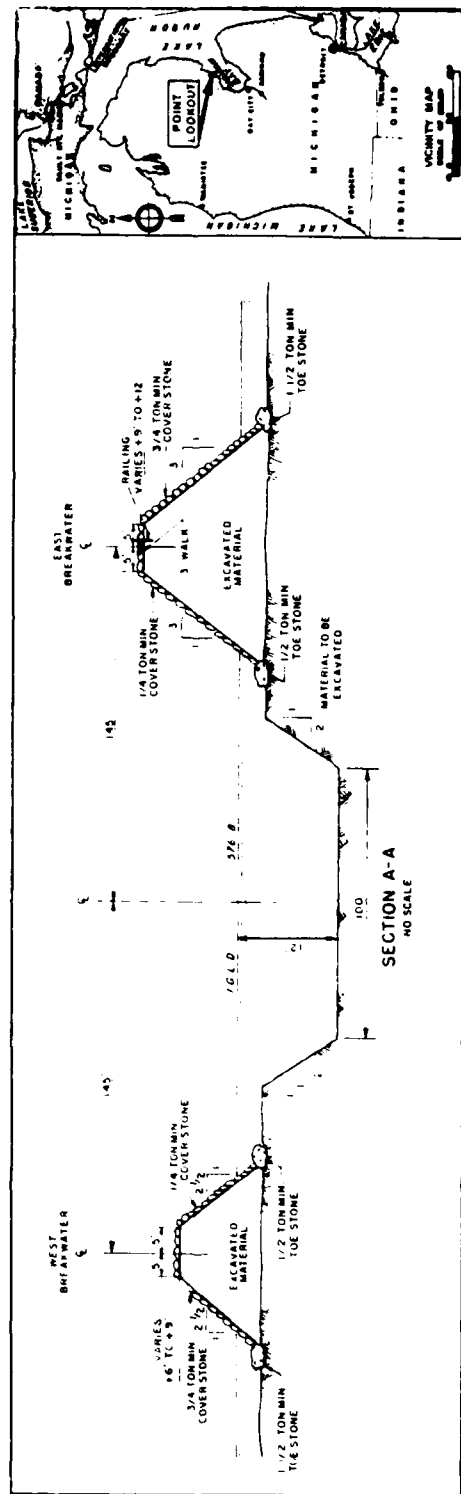
Figure 186. Point Lookout Harbor, Au Gres, Michigan

<u>Date(s)</u>	<u>Construction and Rehabilitation History</u>
1972	Construction of a 4,000-ft-long east and a 3,800-ft-long west breakwater was completed. The breakwaters were rubble-mound structures extending parallel into Saginaw Bay (Figure 186). They consisted of cover stone laid on excavated material. Cover stone on the channel sides consisted of 1/4-ton (min) material, and cover stone on the bay sides of the breakwaters consisted of 3/4-ton (min) material. The breakwaters had 10-ft crest widths and side slopes of 1V:3H for the east breakwater and 1V:2.5H for the west structure. The crest el of the east breakwater ranged from +9 to +12 ft lwd, and the west breakwater had a crest el ranging from +6 to +9 ft lwd (Figure 186).
1976	Approximately 1,300 tons of cover stone (1,500-300 lb) was placed along the bay side of the east breakwater in critical areas to prevent failure of the structure.

1978	Approximately 500 tons of cover stone (3/4 to 1 ton) was placed along the bay side of the west breakwater in areas to maintain stability and prevent failure.
1986	Stone was placed at the harbor, and the structures are currently in good condition. An aerial photograph (photo taken in 1981) of the Point Lookout Harbor breakwaters is shown in Figure 187.

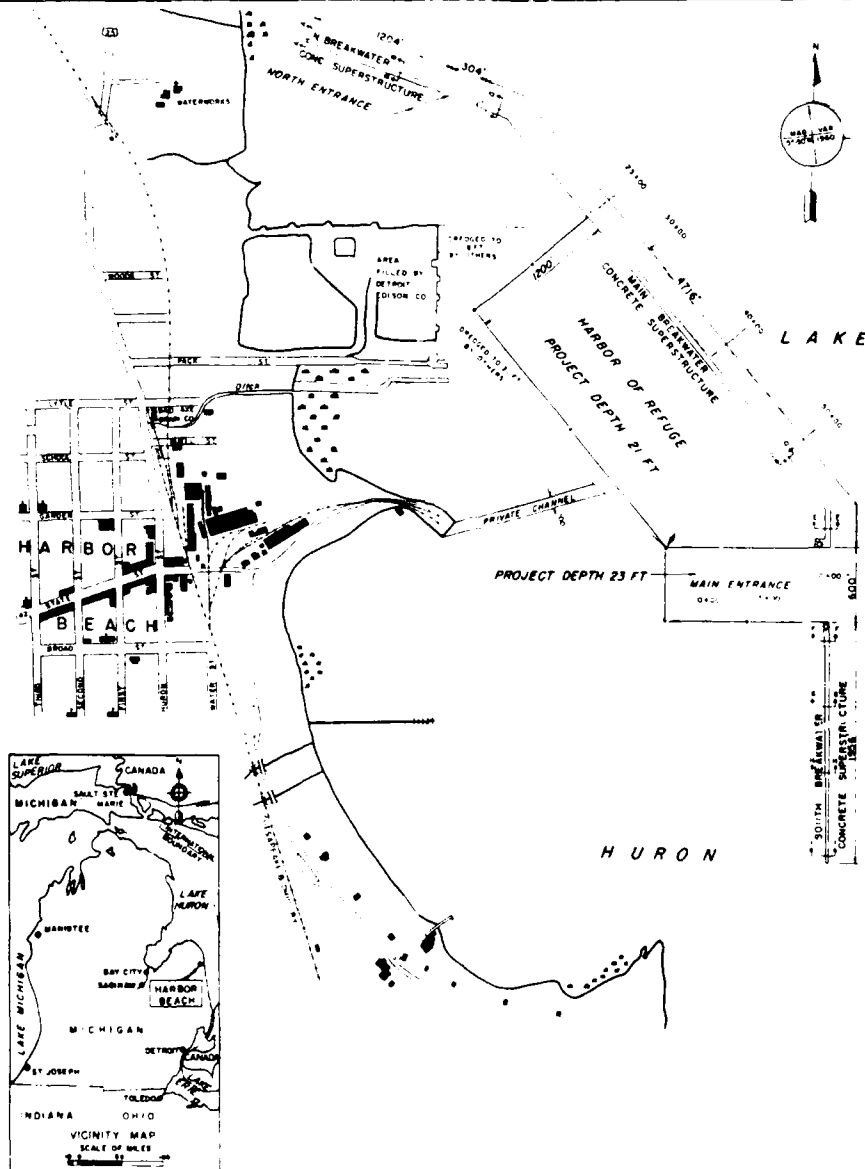
Figure 192. Harbor Beach, Michigan

Date(s)	Construction and Rehabilitation History
1874- 1885	Construction of a 1,204-ft-long north breakwater, a 4,716-ft-long main breakwater, and a 1,956-ft-long south breakwater (Figure 192) was completed during this period. The breakwaters were constructed with stone-filled timber cribs which ranged from 16 to 38 ft in width (Figure 193).
1905- 1909	The main breakwater was capped with a stone and concrete superstructure (Figure 193, Cross Sections D-D and E-E). The superstructure included a parapet that had a crest el of +16.5 ft lwd.
1911- 1912	The north breakwater was capped with a concrete superstructure (Figure 193, Cross Sections A-A and B-B). The breakwater crest el was established at +8.0 ft lwd.
1916- 1917	The south breakwater was capped with a concrete superstructure (Figure 193, Cross Sections F-F through I-I). The crest el of most of the structure was +8.0 ft lwd, but the northern end of the breakwater (Cross-Section F-F) included a parapet with an el of +14 ft lwd.

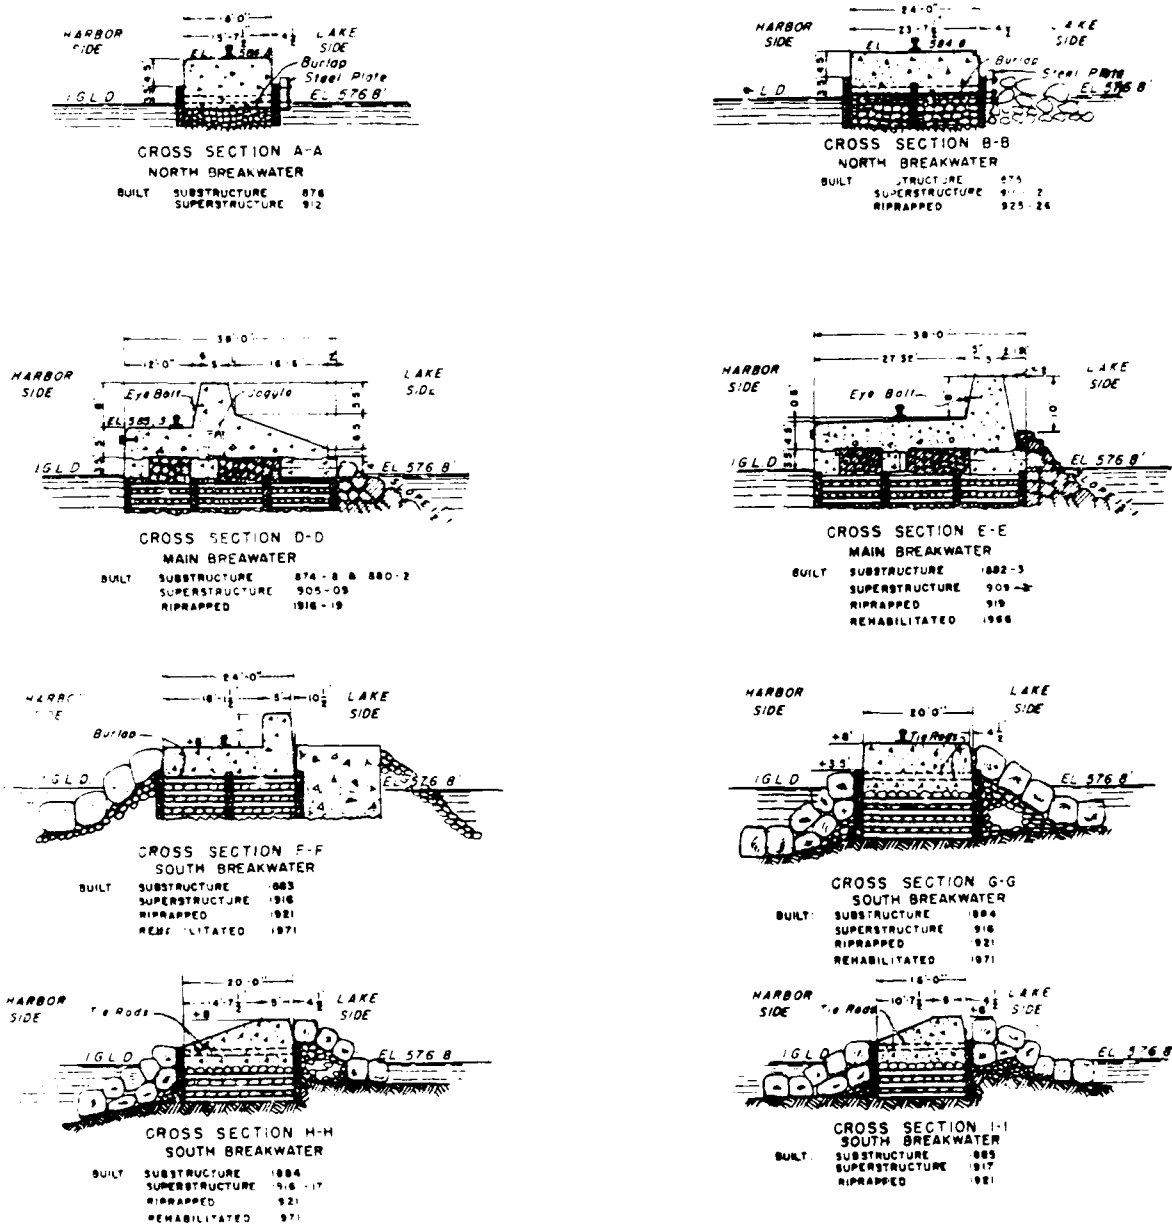
Figure 193. Typical breakwater cross sections, Harbor Beach, Michigan

1916- 1919	Riprap was placed on the lakeside of the main breakwater (Figure 193, Cross Sections D-D and E-E). It was placed on a 1-V:1.5-H slope with a crest ranging from about +3 ft lwd (Cross Section D-D) to +6.5 ft lwd (Cross Section E-E).
1921	Riprap was placed on each side of the south breakwater (Figure 193, Cross Sections F-F through I-I). The crest of the riprap on the lakeside was +8.0 ft lwd, and on the harbor side it was at an el of +3.5 ft lwd.
1925- 1926	Riprap was placed on the lakeside of a portion of the north breakwater (Figure 193, Cross Section B-B) to an el of about +3.5 ft lwd.
1966	Rehabilitation of the south end of the main breakwater (Figure 192, Cross Section E-E) was performed. Work consisted of replenishing stone fill and repairing cracks in the substructures. Cost of the repairs was about \$172,000.
1971	Rehabilitation of portions of the south breakwater (Figure 192, Cross Sections F-F through H-H) was completed. Riprap protection which included a total of approximately 38,500 tons of stone (ranging from 6 to 15 tons each) was performed for about \$676,000.

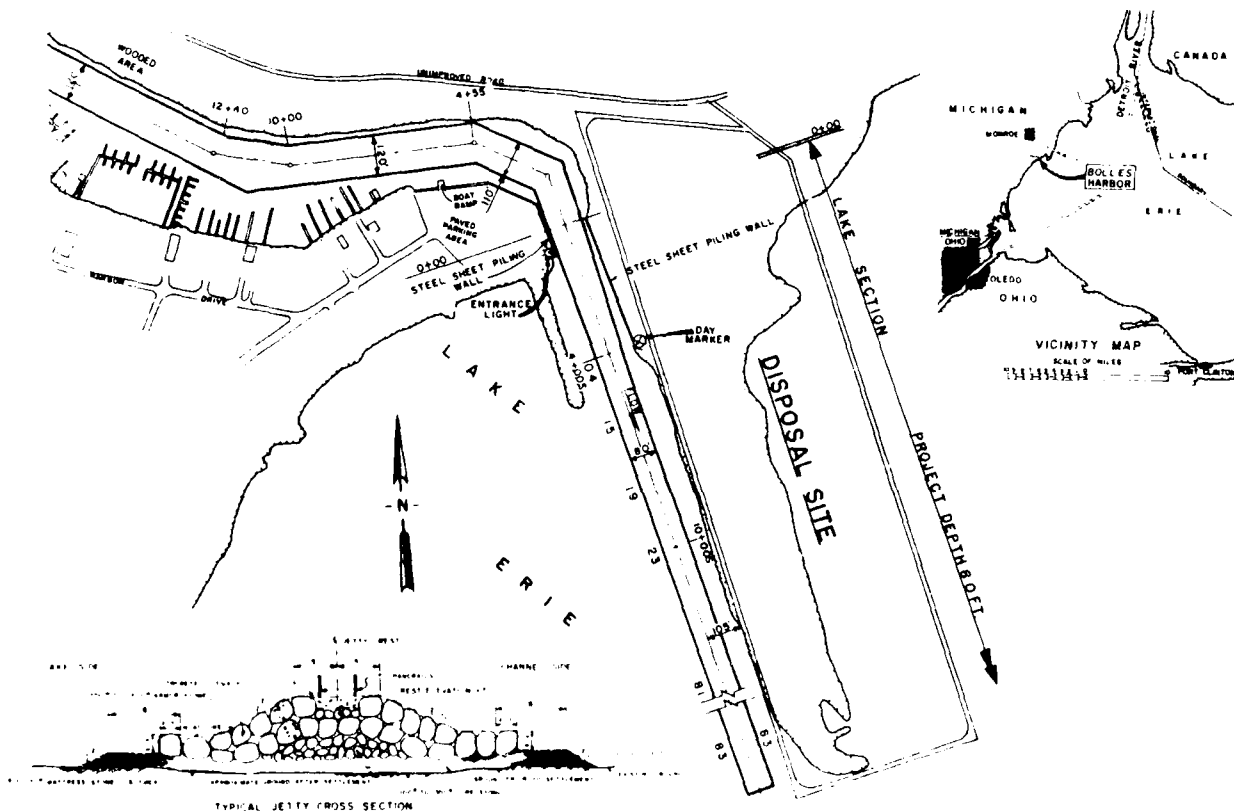
Figure 203. Bolles Harbor, Michigan

Date(s)	Construction and Rehabilitation History
1970	Construction of a 400-ft-long rubble-mound jetty west of the entrance and a disposal site (Figure 203) was completed. The jetty had a 10-ft crest width and an el of +7.0 ft lwd (Figure 203). It included side slopes of 1V:2H and armor stone ranging from 700 to 1,600 lb.
1984	An inspection of the site indicated the jetty was in good condition. There is no record of jetty maintenance.

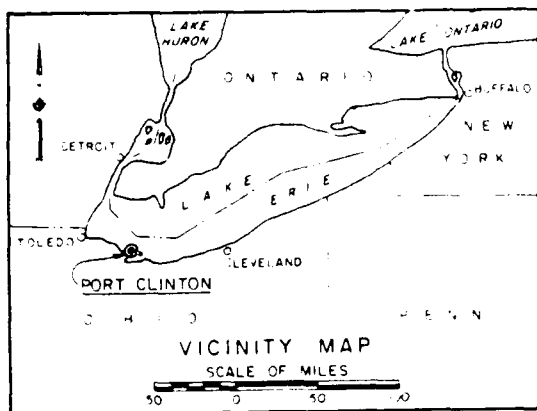
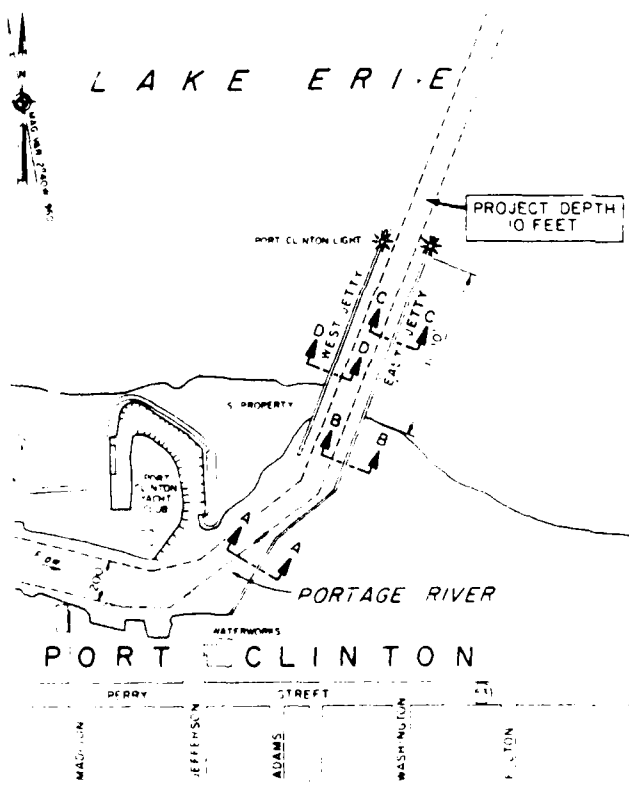
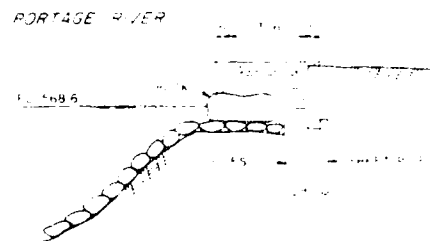
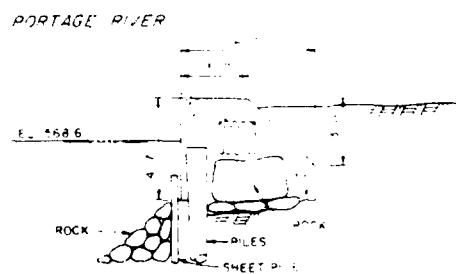
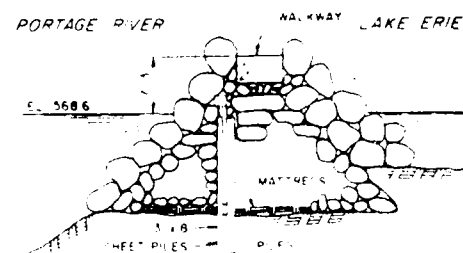
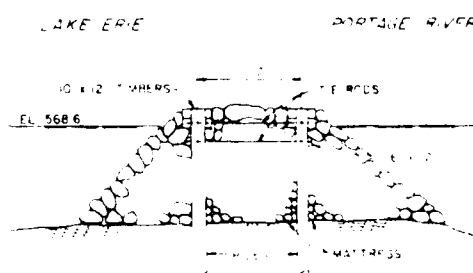
Figure 204. Port Clinton Harbor, Ohio

<u>Date(s)</u>	<u>Construction and Rehabilitation History</u>
1893	Construction of parallel jetties extending lakeward from the mouth of the Portage River (Figure 204) was completed. The original lengths of the east and west jetties were 2,200 and 1,980 ft, respectively. The jetties were constructed of woodpiling and stone. Side slopes of the rubble portions of the structures were 1V:1H.
1963	Breakwater repairs were completed for a cost of \$12,240.
1973	Placement of stone on various portions of the east jetty was completed to repair areas that were washed out and damaged by a large storm in 1972. The cost of these repairs was \$128,860.
1980	An inspection of the site indicated the structures were in very poor condition with the exception of the areas that were repaired in 1973. The jetties were badly deteriorated and sheet pile and additional stone was recommended. It was also recommended that 850 ft of the shore arm of the west jetty be deauthorized since much of it was settled badly and/or buried and it was not considered necessary for shore protection. This deauthorization would result in a west jetty length of 1,130 ft as shown in Figure 204.

1982	Repair of damaged areas of the east jetty was completed. Damaged areas were overlaid with stone similar to that used during construction in 1973. Steel sheetpiling and a concrete cap were installed on the portion of the jetty adjacent to the overbank, and a concrete walkway was installed on the structure originating at the shoreline and extending 1,000 ft lakeward (Figure 204). The crest el of the concrete cap ranged from +3 to +5 ft lwd, and the el of the walkway was +7.25 ft lwd.
1983- 1984	Repairs to the west jetty were completed. Armor stone was placed along the lakeside and the crest of the existing jetty. These stones ranged from 0.5 to 3.5 tons. The crest el after the repairs was +7.3 ft lwd.
1986	The structures are presently considered to be in good condition. An aerial view of the Port Clinton Harbor Jetties is shown in Figure 205.

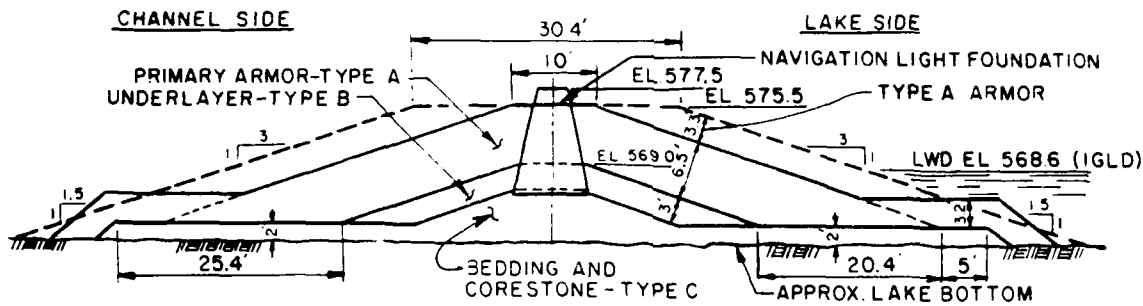
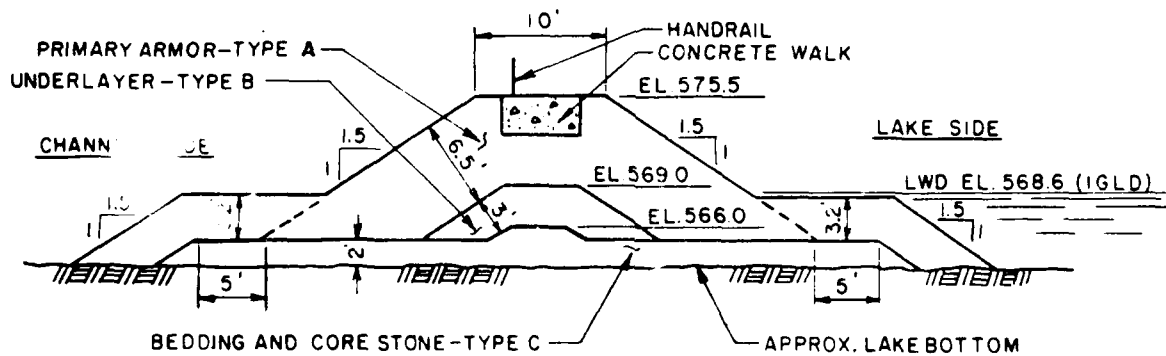
Figure 207. Typical breakwater cross sections, West Harbor, Ohio

STA. 0+00 TO 1+00 ARMOR LAYER 9.8 FT THICK (NORTH AND SOUTH BKW)
 STA. 1+00 TO 2+00 ARMOR LAYER 6.5 FT THICK (SOUTH ONLY)

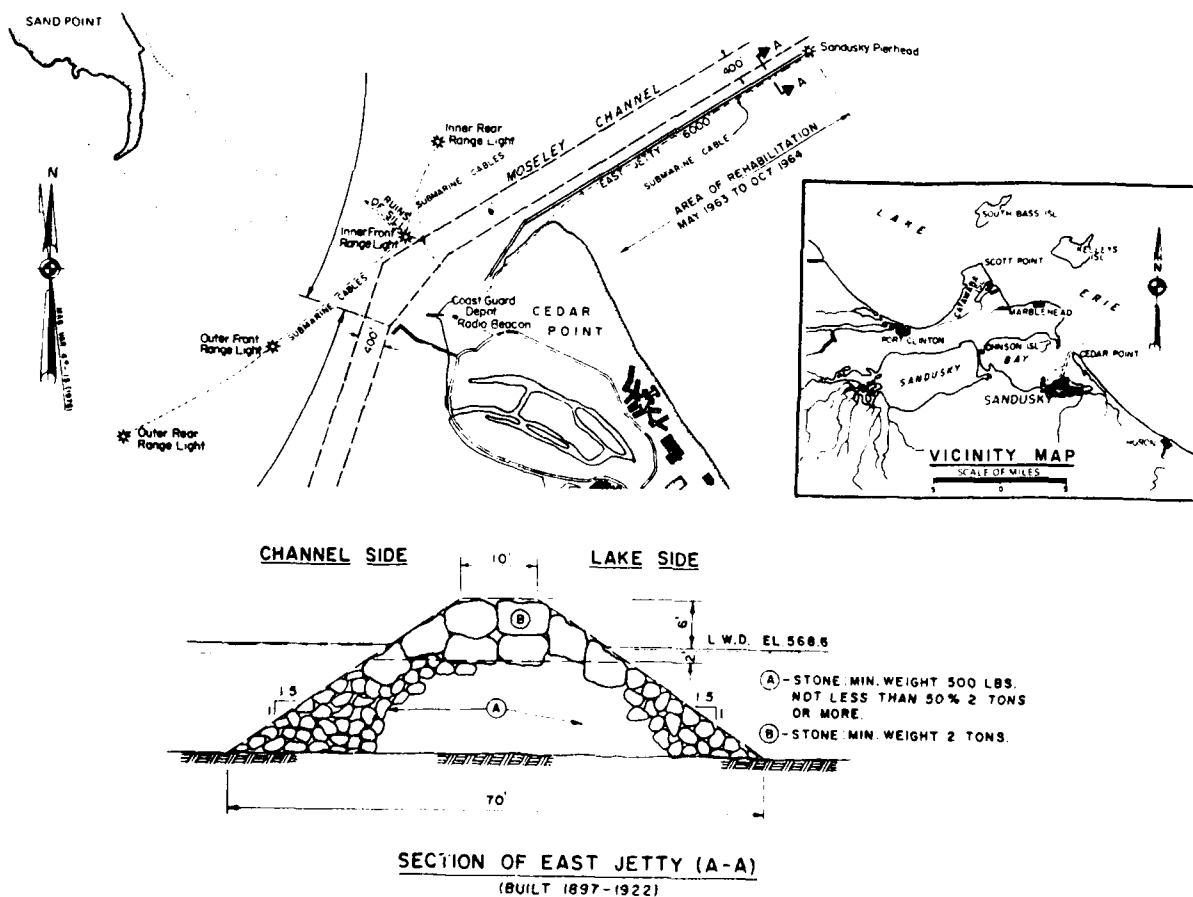
Figure 209. Sandusky Harbor, Ohio

<u>Date(s)</u>	<u>Construction and Rehabilitation History</u>
1897- 1922	Construction of a 6,000-ft-long rubble-mound east jetty was completed (Figure 209) during this time. The jetty had a 10-ft-wide crest with an el of +6.0 ft lwd and side slopes of 1V:1.5H. Armor stone used from an el of about -2 ft lwd to the crest had a minimum weight of 2 tons. Stone used below this el (-2 ft lwd) had a minimum weight of 500 lb and not less than 50 percent was 2 tons or more.
1963- 1964	Rehabilitation of the lakeward 4,000-ft portion of the jetty was completed during this time. The el of the jetty was raised to its authorized height of +6 ft lwd. Armor stone with a minimum weight of 4 tons each was used.
1985	The east jetty was considered to be in poor condition, and repairs were recommended. Estimated costs of these repairs were about \$84,000.

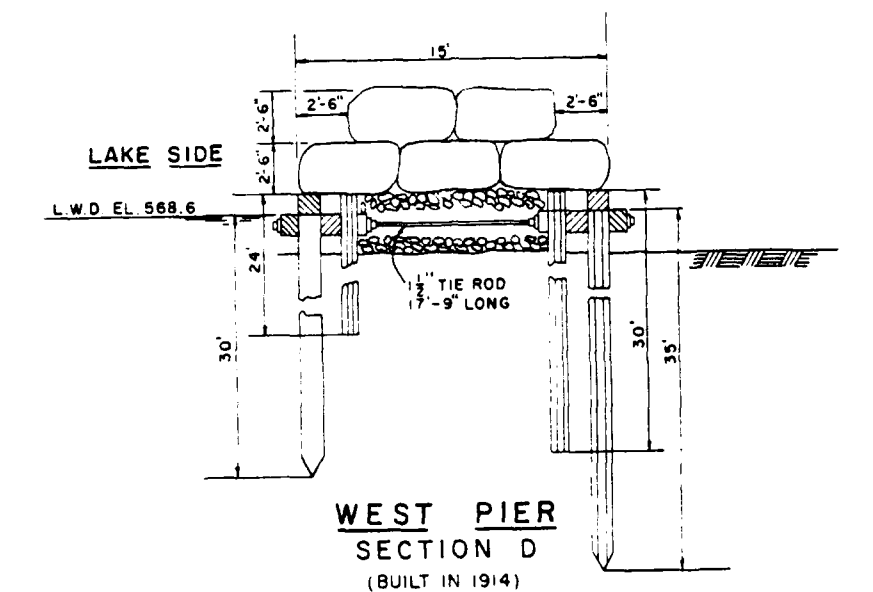
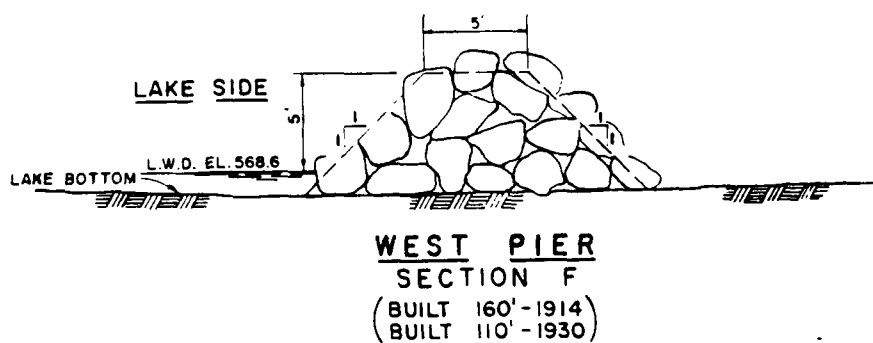
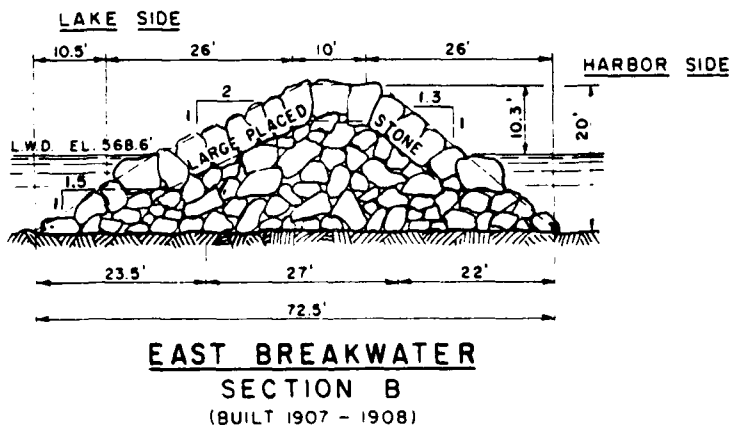
Figure 212. Typical pier and breakwater cross sections,
Huron Harbor, Ohio

1914	A 280-ft-long shoreward extension of the west pier (Figure 210, Sections D and F) was completed. The lakeward portion of the extension involved woodpilings driven about 15 ft apart and filled with stone (Figure 212, Section D). The extension was capped with larger stone (5-ton minimum) and had a crest el of about +6.0 ft lwd. The adjacent 160-ft-long shoreward portion of the extension (Figure 212, Section F) was a rubble-mound structure with a crest width of 5 ft and an el of +5 ft lwd. Side slopes were 1V:1H.
1925	A concrete superstructure was installed on an 800-ft-long portion of the west pier (Figures 210 and 211, Section A). The crest el of this portion of the pier was +6.3 ft lwd.
1930	The shoreward rubble-mound portion of the west pier constructed in 1914 (Figures 210 and 212, Section F) was repaired and extended shoreward an additional 110 ft.
1933- 1934	A 1,360-ft-long rubble-mound extension of the west pier (Figure 210, Section E) was constructed during this period. The breakwater had a crest width of about 8 ft and an el of +8 ft lwd. Side slopes were 1V:1.3H (Figure 211, Section E). Armor stones with a minimum weight of 3 tons, and not less than 50 percent being 5 tons or more, were used.

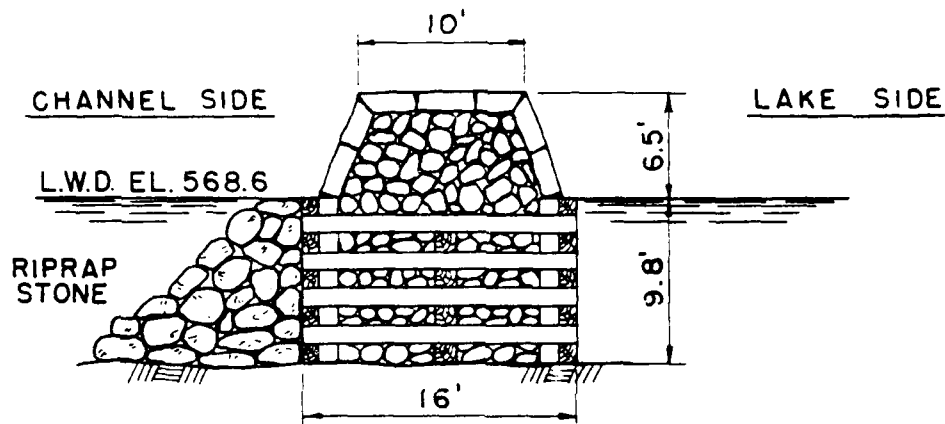
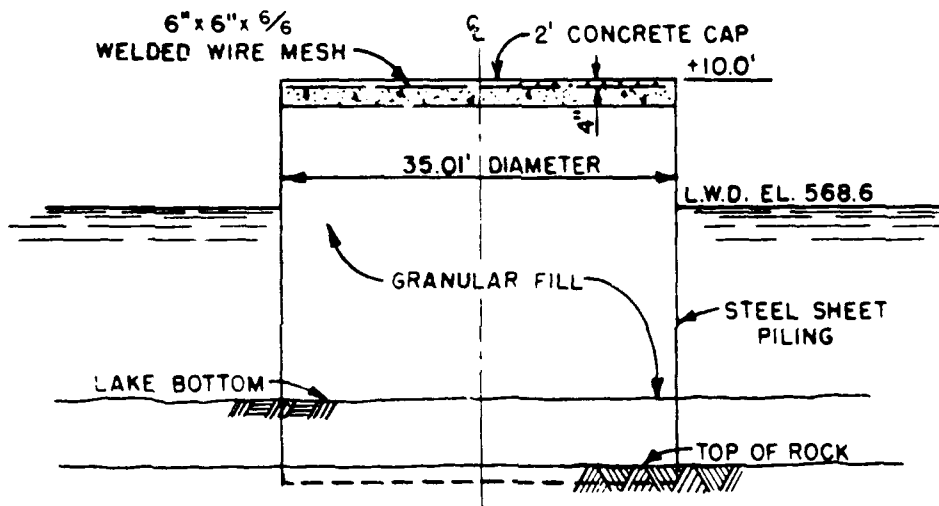
Figure 215. Typical structure cross sections,
Vermilion Harbor, Ohio

Date(s)	Construction and Rehabilitation History
1836- 1839	Construction of parallel piers at the mouth of the Vermilion River was completed. The piers extended to the -10 ft lwd contour and had crest els of about +5.0 ft lwd. They were stone-filled timber crib structures, and were 16 ft in width.
1874	The east and west piers were extended to the -12 ft lwd contour. No other lakeward extensions have been made. The east pier is 458.5 ft long, and the west pier is 1,333.5 ft long (Figure 214).
1906- 1914	A heavy stone superstructure was installed on both piers (Figure 215) to els ranging from +6 to +6.5 ft lwd. The crest width was 10 ft.
1964	Rehabilitation of 450 ft of the west pier and 230 ft of the east pier was completed (Figures 214 and 215). The crest els of these portions were raised to +6.5 ft lwd, and riprap was installed on the lakesides of the structures.
1973	Construction of an 864-ft-long detached breakwater (Figure 214) was completed. The breakwater was a cellular steel sheet-pile structure with 35-ft diameter cells. The cells were granular filled and capped with concrete at an el of +10 ft lwd (Figure 215). The offshore breakwater was model tested (Brasfield 1970) prior to construction.

REHABILITATION OF 450 FEET OF WEST PIER
AND 230 FEET OF EAST PIER INITIATED IN
JUNE 1964 AND COMPLETED IN OCTOBER 1964.
(TOP ELEVATION RAISED TO 6.5 FEET ABOVE
L.W.D. AND RIPRAP STONE PLACED ON LAKE
SIDE.)

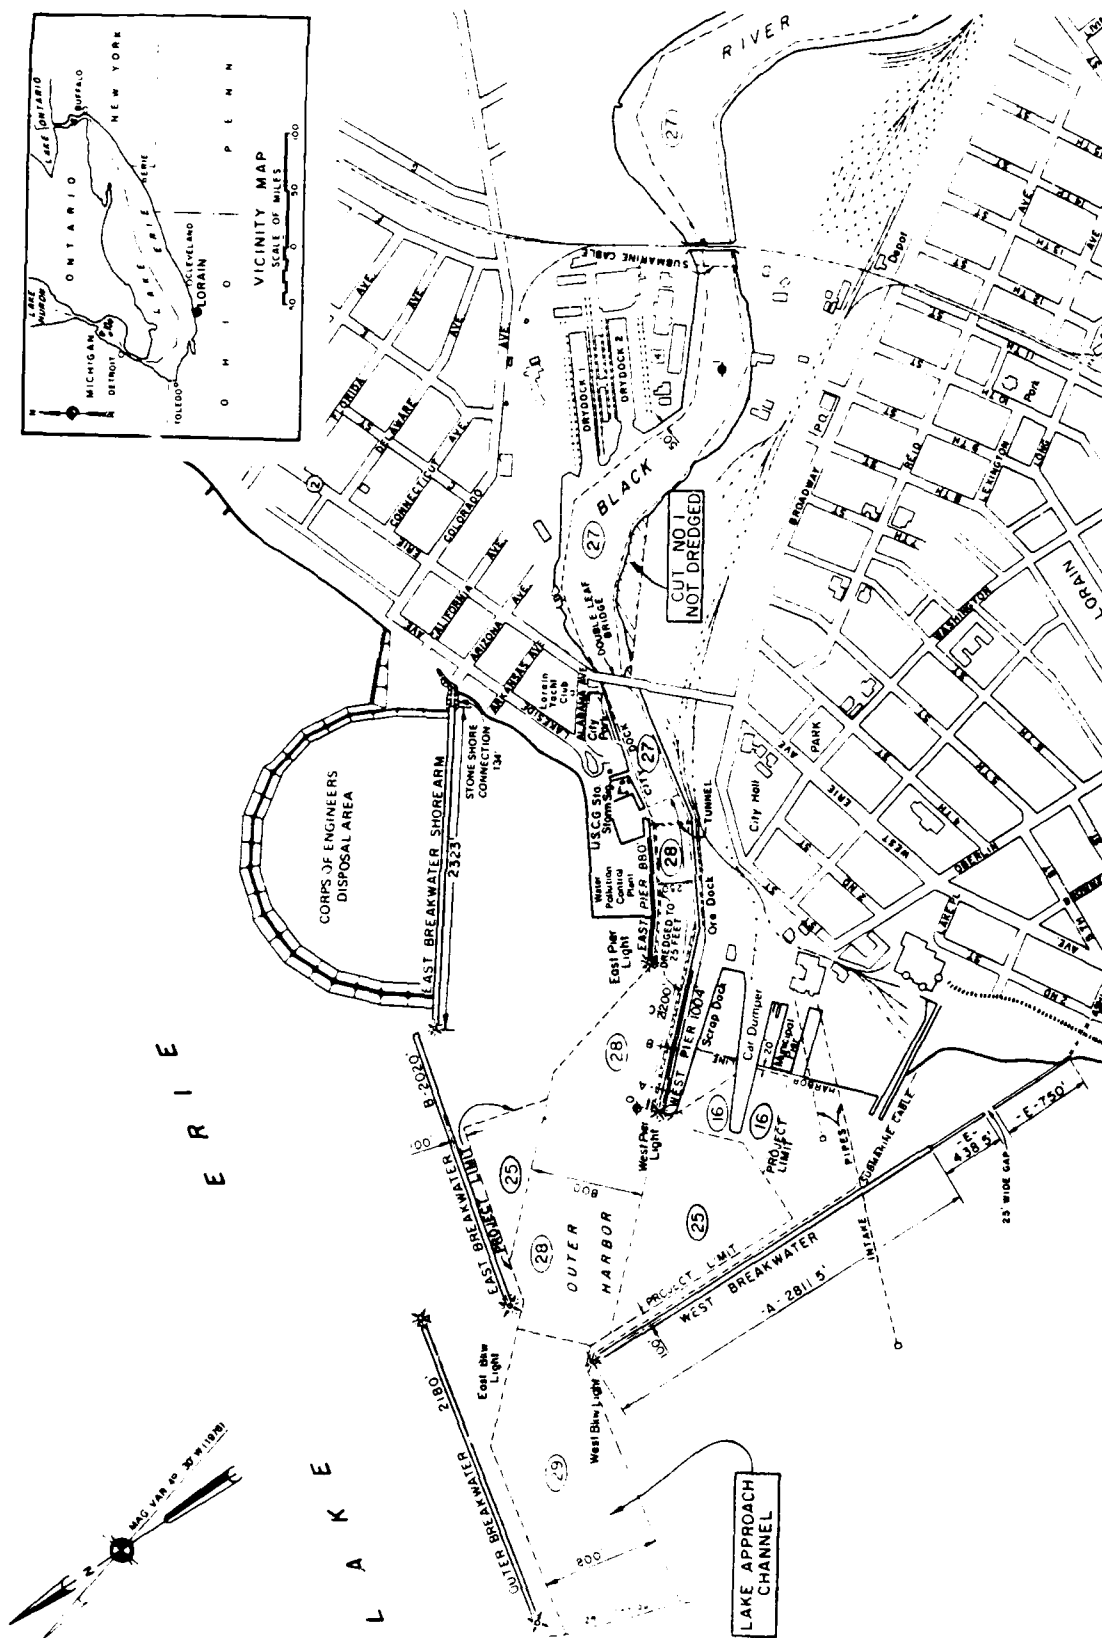
Figure 219. Lorain Harbor, Ohio

1977	A combination rubble-mound and steel sheet-pile dredge disposal dike was constructed and attached to the east breakwater shorearm.
1986	Recent site inspections indicated that portions of the rubble-mound stone sections of the structures show localized damage and considerable settlement. The structures are considered in fair condition, and no repairs are planned in the near future. An aerial photo of the Lorain Harbor structures is shown in Figure 222.

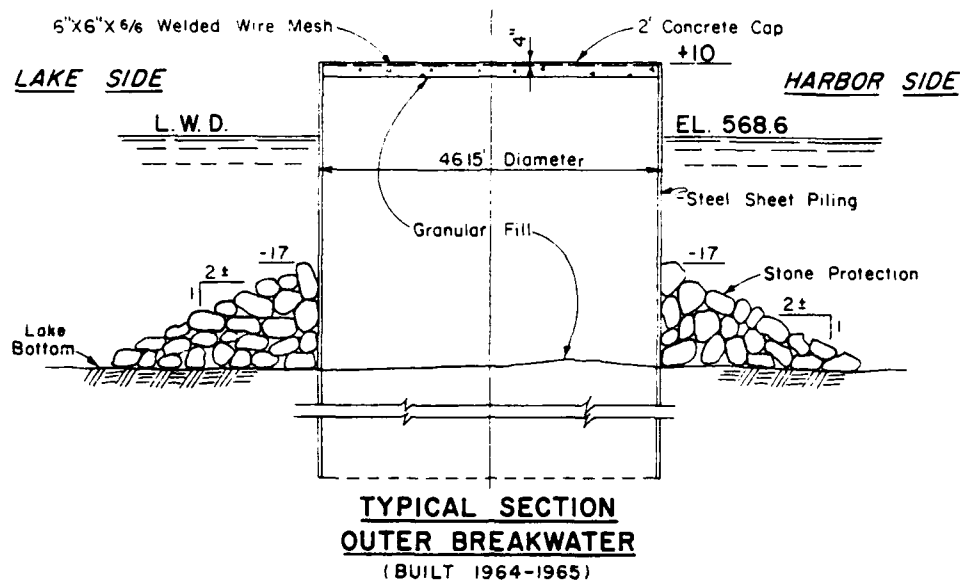
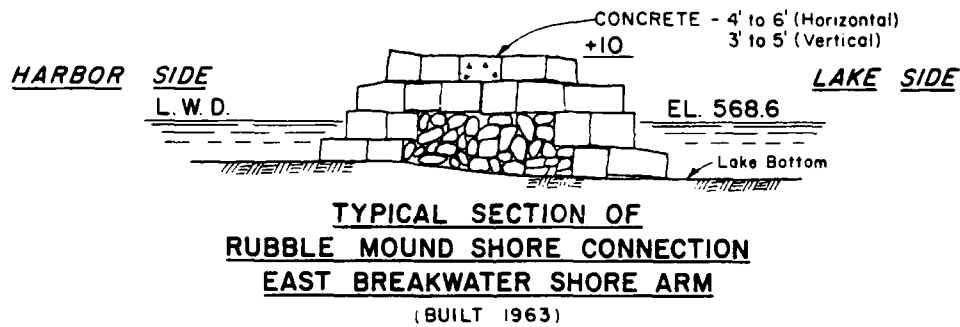
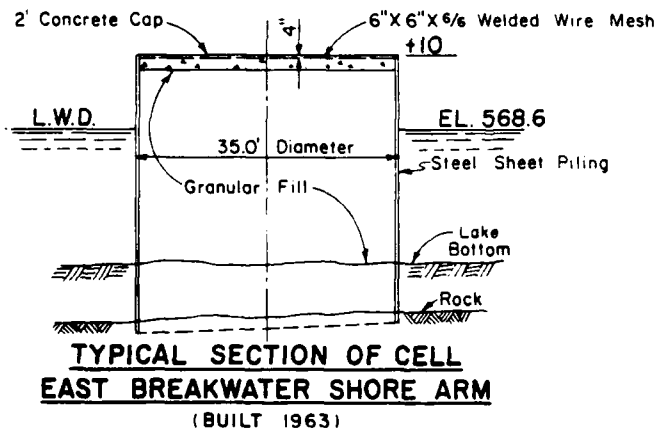
Figure 221. Typical breakwater cross sections,
Lorain Harbor, Ohio

1963	Construction of a 2,457-ft-long east breakwater shore arm (Figure 219) was completed at a cost of about \$2.7 million. The outer 2,323 ft was a granular-filled concrete capped cellular steel sheet-pile structure. The cells had a 35-ft diameter with a crest el of +10 ft lwd (Figure 221). Also included was a 134-ft-long rubble-mound shore connection (Figure 219). The rubble-mound portion had a crest el of +10 ft lwd and was capped with rectangular blocks (Figure 221).
1964- 1965	The lakeward 995-ft portion of the east pier was removed leaving an 880-ft-long pier, and the lakeward 280-ft portion of the east breakwater was removed resulting in a structure 2,020 ft in length (Figure 219). A 2,180-ft-long granular-filled cellular steel sheet-pile outer breakwater was constructed (Figure 219). Cell diameters were 46.15 ft, and the breakwater was capped with concrete to an el of +10 ft lwd (Figure 221). Riprap toe protection also was placed adjacent to both sides of the breakwater. This modification was model tested (Wilson, Hudson, and Housley 1963).
